## Material Numbers Affected: CP150 – all versions

### Overview

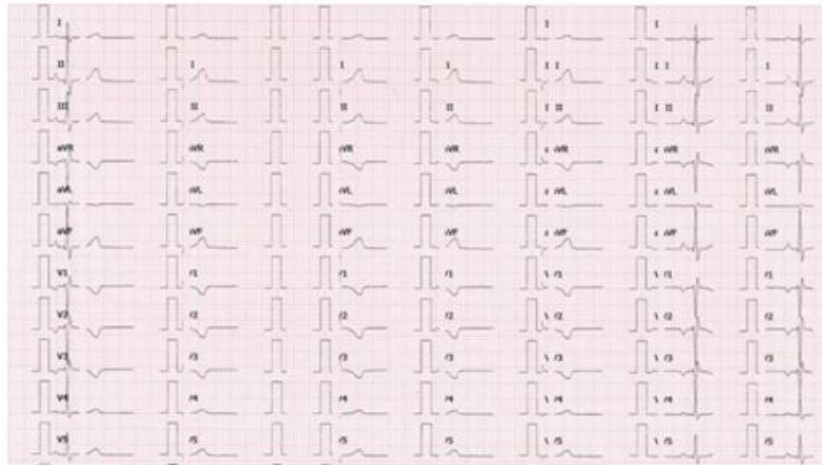
- As of 12/16/2015, there is a Stop Ship for all CP150 models
- It has been found that there is a rhythm printing issue with the CP150 2.00.05 firmware version. The rhythm print starts and stops repeatedly – as shown:

- No other functions in the device are affected
- CP150 2.00.03, which was the previous firmware version, does not have this issue. The impacted firmware 2.00.05 was implemented in July 2015.
- CP150 Firmware version 2.00.06 will remedy this issue and is expected to go into production during the week of December 28

1. Do a full shutdown of the device by holding down the power button for 6 seconds
  2. Power the device back on
  3. Be sure the rhythm print is the **first test** performed on the device following the power cycle
- Currently, we are not asking customers to send their device in for repair. Until the updated 2.00.06 firmware is available, we will create a ZZ notification to track customers that call in with this issue so that we can follow up and deliver the firmware update when it becomes available
  - Since its release in July 2015, approximately one thousand (1,000) CP150s have been shipped with Version 2.00.05 and could possibly experience this issue. Devices that have been upgraded to Version 2.00.05 will also be affected. The issue might not occur for every customer that uses the CP150 with Firmware 2.00.05 depending on the workflow and tests performed on the device
